# On the use of artificial intelligence and no-tension models in the post-earthquake preliminary assessment of masonry structures

Fernando Fraternali <sup>a,\*,</sup>, Hazar Etteyeb <sup>a</sup>, Angela Lato <sup>a</sup>, Rana Nazifi Charandabi <sup>b</sup>, Mario Spagnuolo <sup>a</sup>, Carlo Olivieri <sup>c</sup>, Francesco Fabbrocino <sup>c</sup>, Angelo Ciaramella <sup>d</sup>, Ada Amendola <sup>a</sup>

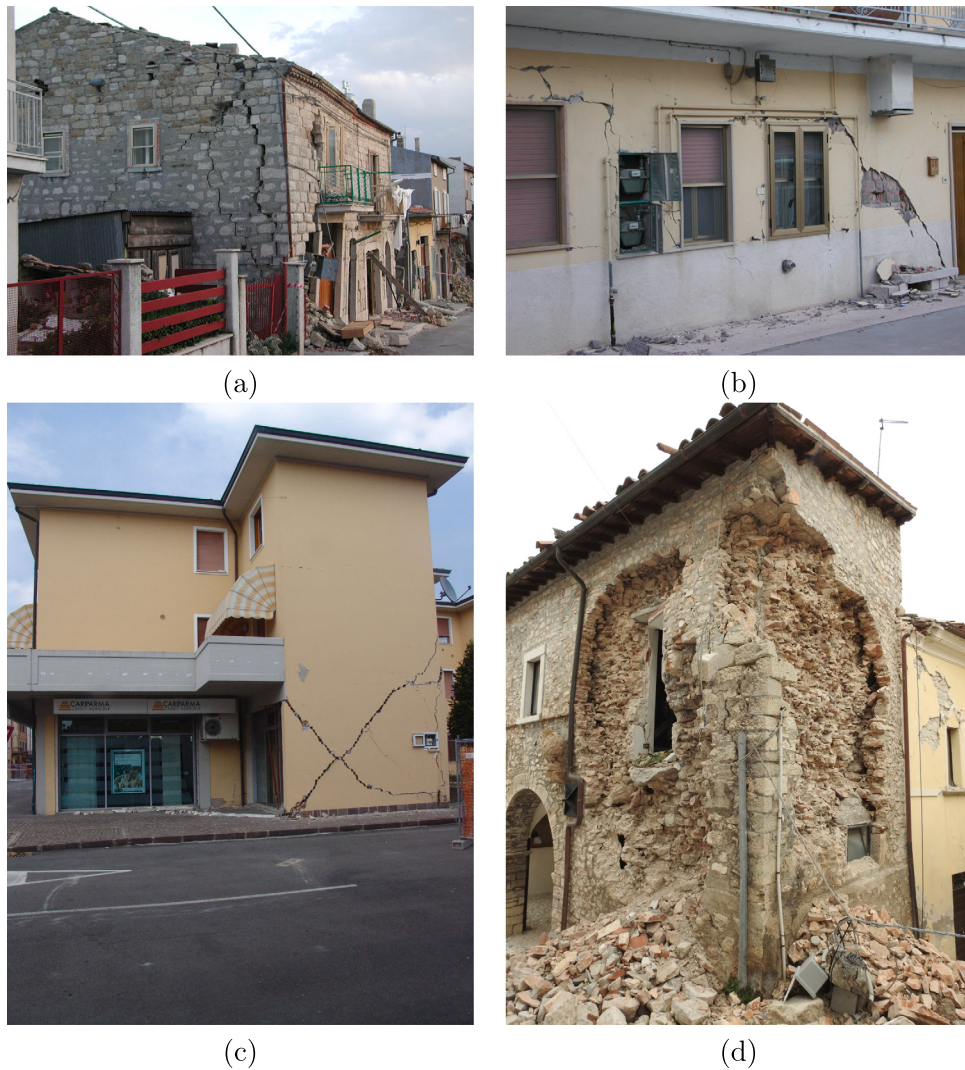
**Fig. 1.** Illustration of various unannotated images included in the employed training dataset. (a,b) City of San Giuliano di Puglia, Molise earthquake: (a) vertical crack causing the separation of two orthogonal masonry walls in a two-story building; (b) combination of horizontal, vertical, and diagonal cracks in the masonry portion (right side) of a mixed reinforced concrete–masonry structure. (c) City of Novi di Modena, Emilia–Romagna earthquake: X-shaped crack on the masonry wall of the right-hand portion of a building constructed in masonry, adjacent to an undamaged section built in reinforced concrete (left side). (d) City of Preci (Perugia), Norcia earthquake: spalling at the intersection of two orthogonal double-leaf masonry walls.

We begin by illustrating the images shown in Fig. 1, which consist of unannotated samples taken from the training dataset. The photograph in Fig. 1(a) shows a two-story building in San Giuliano di Puglia

damaged by the 2002 Molise earthquake. The structure did not exhibit a box-like behavior; as a consequence, the masonry piers oscillated asynchronously under the seismic action. The façade wall, in particular, rotated outward toward the street, creating two clearly visible vertical separations on the adjoining wall to which it had been connected. The street-facing wall was especially vulnerable because the ground floor contains several large openings, considerably wider than those on the upper level. Fig. 1(b) illustrates the damage sustained on the ground floor of another building in the same city, also affected by the 2002 Molise earthquake. This structure was built using mixed masonry, with stone blocks alternating with hollow clay bricks, and features large openings at the ground floor. Shear cracks can be observed at the first level, together with some spalling in the areas composed of hollow bricks. Fig. 1(c) illustrates the seismic damage sustained by a relatively new building in the municipality of Novi di Modena during the Emilia-Romagna earthquake. The structure exhibits notable structural deficiencies. The left portion was constructed with a reinforced concrete frame, featuring large ground-floor openings where shop windows were installed, while the right portion consists of load-bearing masonry walls. As a result, there is a pronounced eccentricity between the centers of mass and stiffness, further accentuated by the presence of two stairwells located in the masonry section, both of which experienced significant damage. As expected, the seismic forces produced the most severe effects in the masonry portion of the building. Finally, Fig. 1(d) shows the damage sustained by a building constructed with rubble-filled masonry (*muratura a sacco*) in the municipality of Preci (Perugia), which was affected by the 2016 Norcia earthquake. The widespread spalling observed on the outer wythe at the corner of the building indicates that the two masonry leaves forming the load-bearing walls did not act together during the seismic event, as they were not properly interconnected.

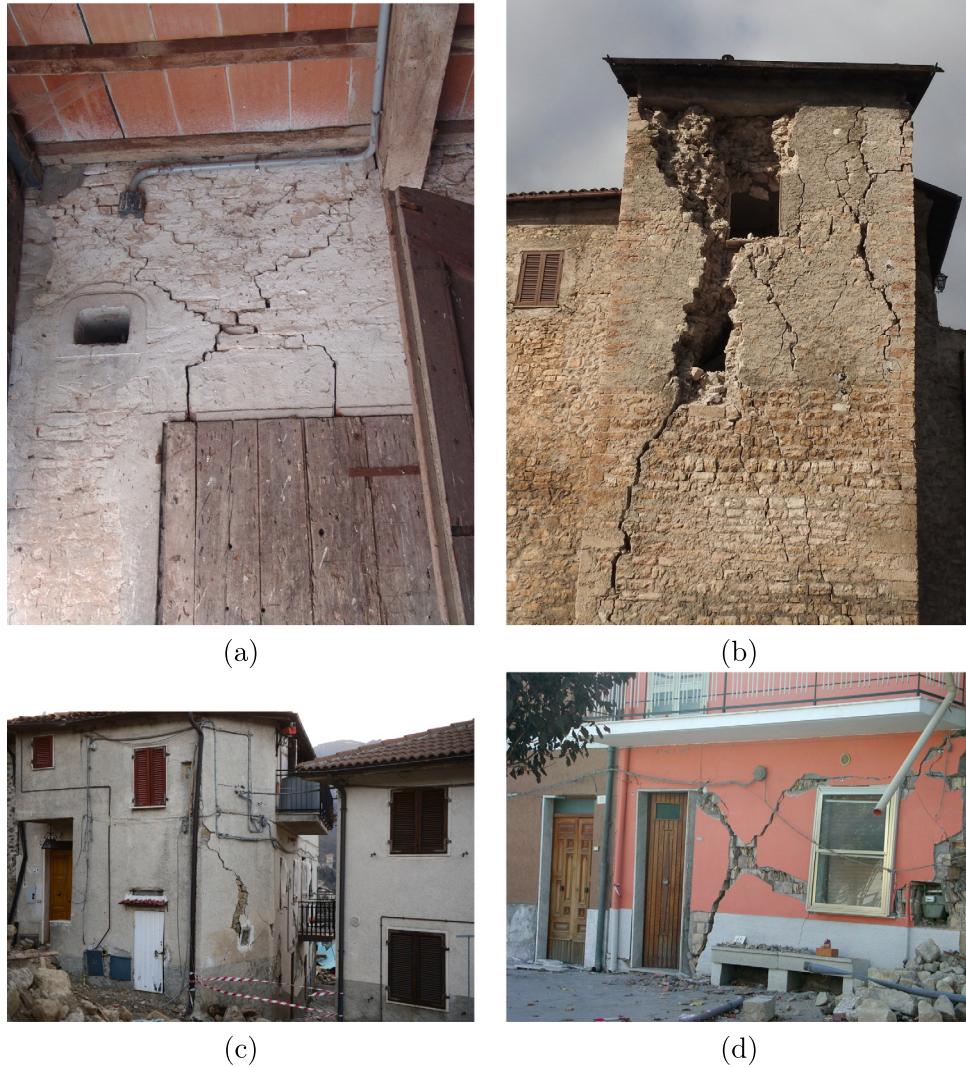
**Fig. 2.** Illustration of selected images contained in the validation dataset prior to annotation. (a) Crack damage inside a building struck by the 2012 Emilia–Romagna earthquake, visible above an opening lacking a reinforcing lintel; (b) Detection of masonry spalling on the external wall surface and cracking in a section of the city walls of Norcia, damaged by the 2016 earthquake, built with rubble-filled masonry; (c,d) Detection of shear cracking damage in two buildings in the city of San Giuliano di Puglia, struck by the Molise earthquake.

Fig. 2 shows unannotated images extracted from the validation subset of the photographic database. The case illustrated in Fig. 2(a) refers to shear cracks observed inside a building damaged by the 2012 Emilia-Romagna earthquake, above an opening that had not been reinforced with an adequate lintel. The presence of a floor structure made of wooden beams and hollow bricks can also be observed. Fig. 2(b) shows severe detachment damage affecting the external facing of a portion of the city walls of Norcia, struck by the 2015 earthquake, built in rubble core masonry. Widespread cracking damage is also visible in the same facing. Finally, Fig. 2(c,d) show shear damage in two buildings located in San Giuliano di Puglia, affected by the 2002 Molise earthquake, corresponding to an oblique wall and a front wall, both situated on the ground floor.

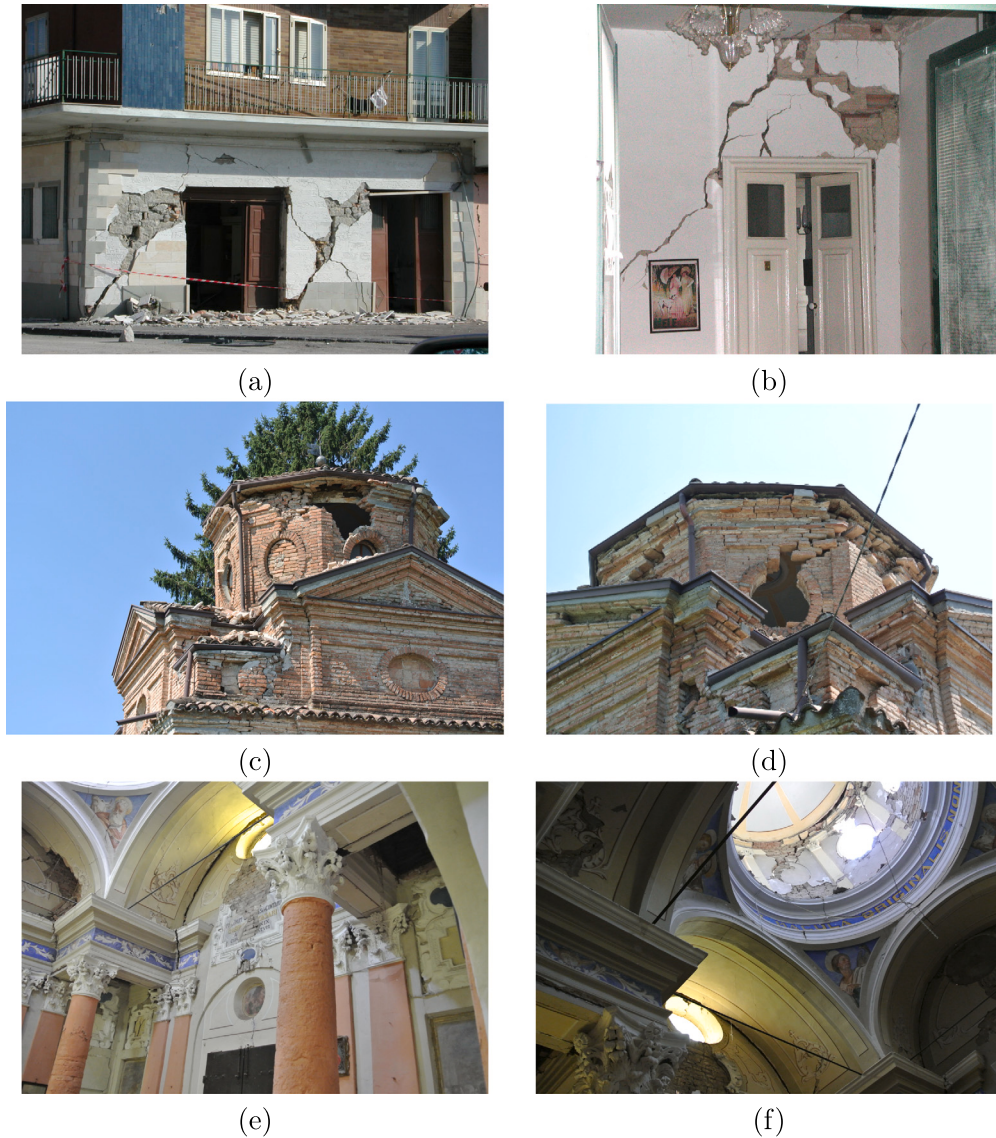
**Fig. 3.** Illustration of selected images included in the test dataset before the application of the CNN damage-detection procedure. (a,b) Shear damage on the ground floor (a) and in the interior (b) of buildings located in the city of San Giuliano di Puglia, affected by the 2002 Molise earthquake; (c–f) Cracking and spalling damage observed on both the exterior and interior of the Gasparini Casari Chapel, located in the Province of Modena and affected by the Emilia–Romagna earthquake.

Moving on to the figures included in the test subset of the image database, we note that Fig. 3(a,b) illustrate the shear damage observed on the ground floor of the façade of a building located in San Giuliano di Puglia (a), and the similar damage that occurred near a doorway inside another building in the same town (b), both affected by the 2002 Molise earthquake. In Fig. 3(a), one can observe, on the ground floor, very wide openings that are not aligned with those on the upper level, as well as masonry with an irregular texture, consisting of stone portions alternating with sections of hollow brick. A similar type of masonry can be observed in Fig. 3(b), where the collapse of a portion of the floor with brick vaults supported by iron beams above the opening is also evident; this was certainly the cause of the observed shear-related damage.

We conclude with the examination of the spatial domed structure shown in Fig. 3(c-f). This structure covers the central part of the Gasparini Casari chapel, also known as the Oratory of the Immaculate Conception, located in Novi di Modena (MO), in the Sant'Antonio in Mercadello area, on Via Mazzarana (GPS coordinates: 44.8757738, 10.9598901). The chapel was severely affected by the 2012 Emilia-Romagna earthquake. Fig. 4 provides further details concerning the damage observed at the drum of the central dome following the earthquake (panels a,b), as well as exterior views of the chapel before and

The most severe damage caused by the 2012 earthquake is concentrated in the drum and is likely attributable to an eccentricity in the closure of the oculi and to the absence of an adequate ring beam. Figs. 3(c,d) and 4(a,b) illustrate the detachment along the edges of several brick infills closing the oculi, together with the absence of an adequate ring beam at the roof level. Finally, Fig. 3(e,f) document the presence of tie rods at the springing of the four arches supporting the weight of the drum, which appear to have prevented its collapse by effectively restraining the supporting base.

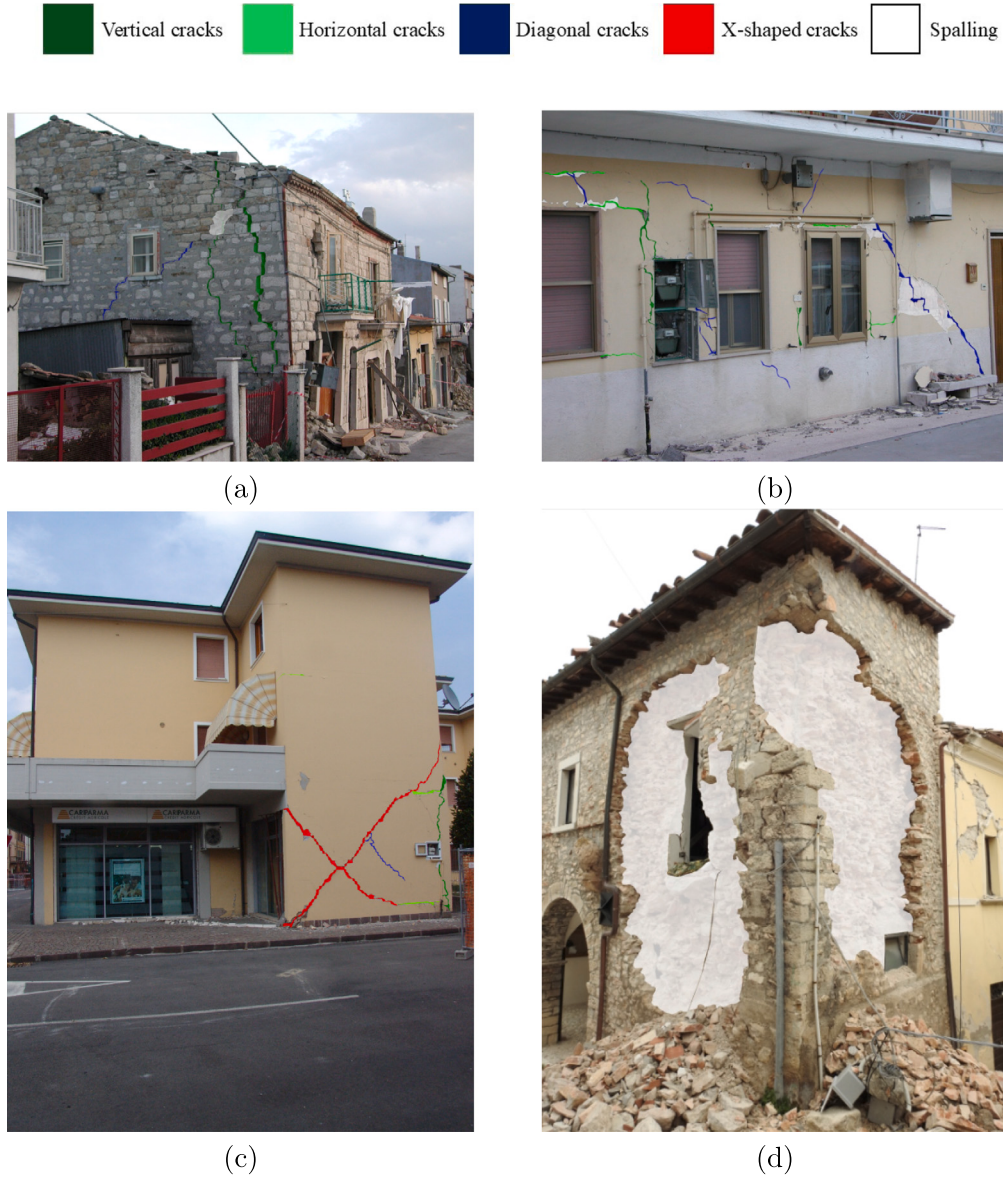
**Fig. 5.** Training phase: annotation of the images shown in Fig. 1. In this and the following figures, the defined damage classes include vertical, horizontal, diagonal, and X-shaped cracks, as well as masonry spalling, represented by the color codes displayed at the top of the figure.

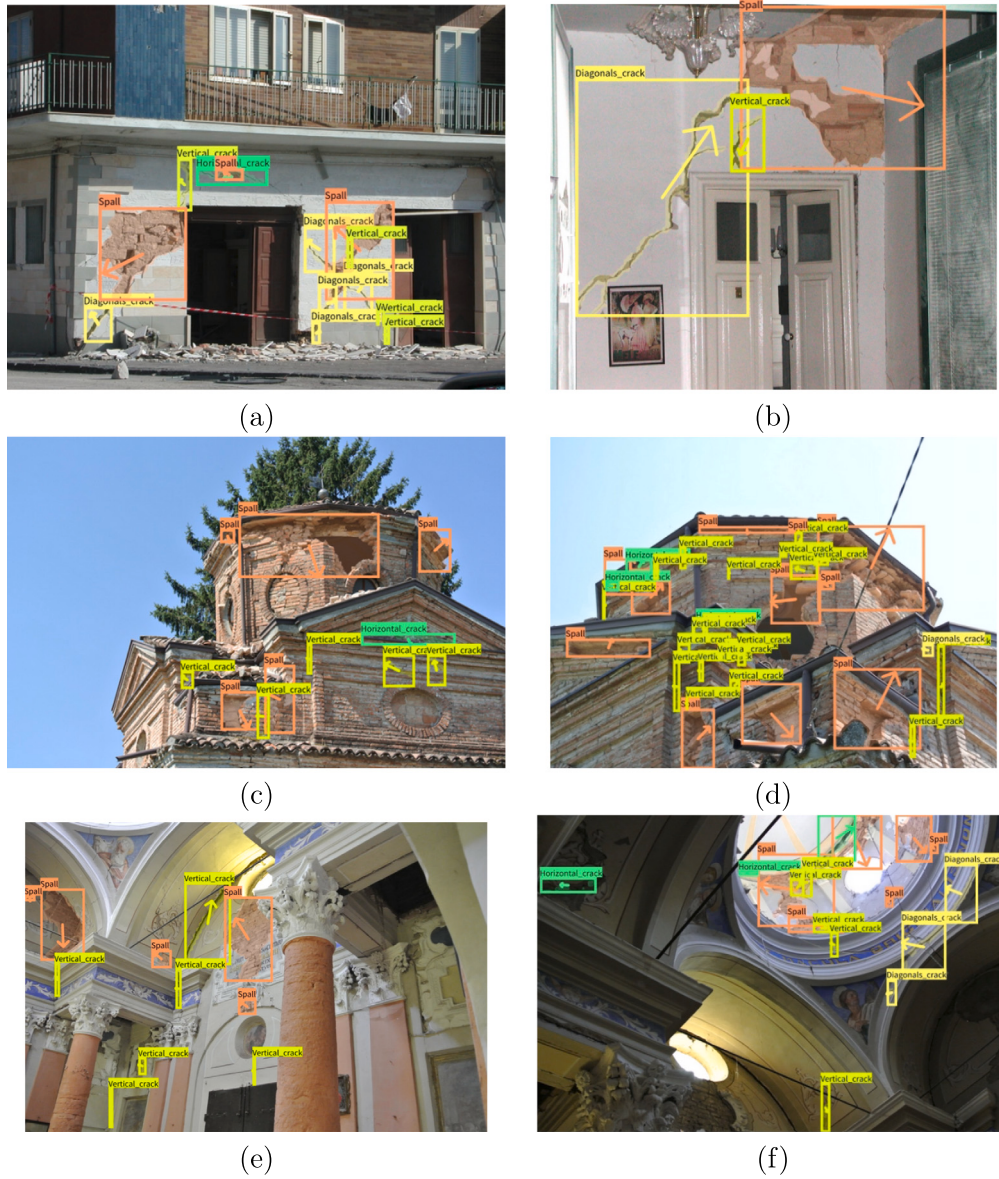
Fig. 7. Test phase: detection of damage in the images shown in Fig. 3.

We examined an undamaged model of the wall and two damaged models, as illustrated in Fig. 11. The analyzed obstacles correspond to the detached portions of the cracks detected in Fig. 7(a), as well as to the door openings at the ground floor. The two damaged models differ from each other, because in the second one we assumed a larger extension of the detachment fractures compared with the first model. In other words, the additional obstacles shown in Fig. 11 were assumed to correspond to superficial cracks in the first damaged model, which do not compromise the local stress-absorption capacity of the masonry.
